Reprogramming Procedure for the Princess 5000 lateral tilting bed.

Reprogramming Procedure:

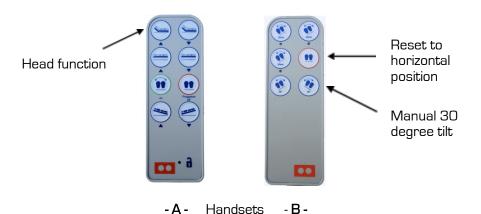
Remove the power plug from mains outlet. Leave unplugged for a minimum of 30 seconds. Hold handset **A.** press the top left hand button (Head Function: up) once.

Replace the power plug into mains outlet and switch on. Hold handset **B**, continually press the bottom right hand button (manual 30 degree tilt) until fully tilted, now press the button directly above (button with the red outline) once, to reset to the sleeping platform to the horizontal position.
